# Level 1 Supervision & Inspection Report

## **KING STREET WALLAN – STAGE 1**

Prepared for Newnham Earthmoving Pty Ltd

24/04/2024

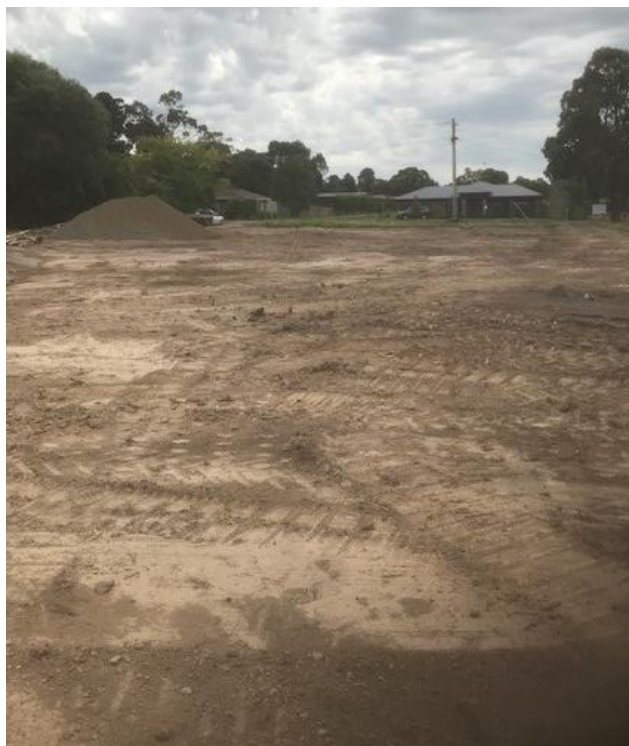
Figure 1: Level 1 Stripping Inspection - 22/03/2024

Prior to commencement of earthworks, Construction Sciences confirmed that all unsuitable and weaker material such as top soil, silt, uncontrolled or loose soil, organic affected material and other wet areas had been appropriately stripped as specified in AS 3798-2007.

The contractor was instructed to remove any root- affected materials in the surface soil and soft spots prior to the commencement of level 1 filling in accordance with AS 3798 2007 Section 6.1.5 Stripping. On 22/03/2022, the Construction Sciences Level 1 GITA personnel visited the site to inspect the stripped zone where no unsuitable materials encountered. Fill material consisted of low plastic silty clay sourced from the onsite sewer spoil and imported fill from Hidden valley, conditioned onsite and compacted in place.

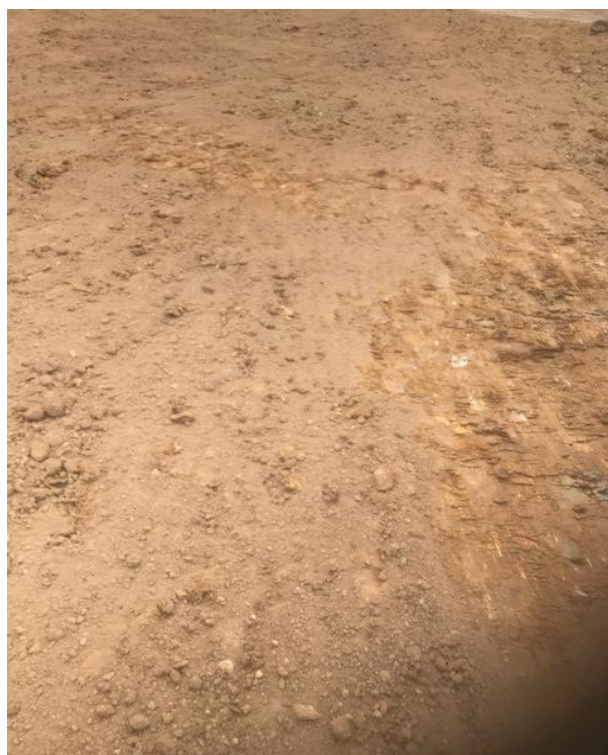
Figure 4: Level 1 Existing material onsite - 22/03/2024

The fill material typically comprised of:

- Silty Clay, medium to highly plastic, light brown/grey (Onsite);
